# SAT Analysis report for Bibalan Rural District (Gilan Province) Flood

Farvardin 1404

Tehran Reinsurance  
Company

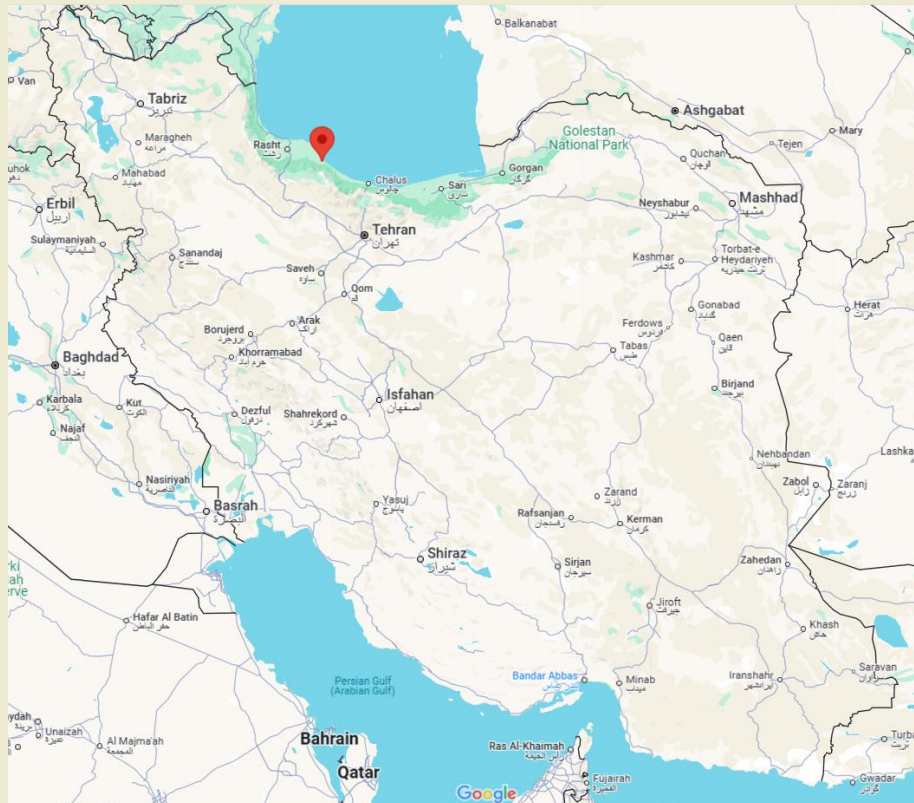
Image 1: Flood incident site

- Incident: Flood
- Cause: Rainfall and flooding
- Location: District Rural Bibalan - Gilan Province
- Incident Coordinate : 37.09°N, 50.3775°E
- Elevation: -24 meters
- Date of incident: 2nd and 3rd Farvardin 1404 (March 22–23, 2025).
- Damage: During the incident, two bridges were destroyed and access to approximately 200 villages in the Ashkourat and Rahimabad regions was blocked. Additionally, two local residents were reported missing.

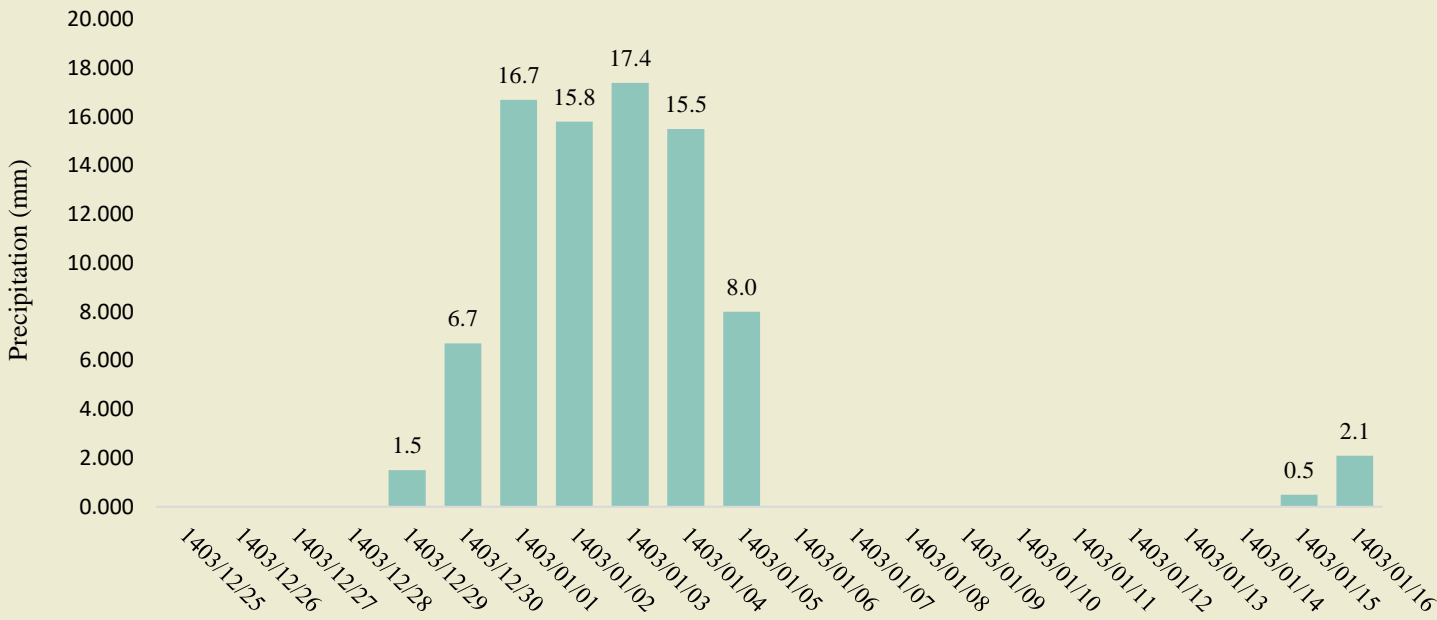
Chart 1: Precipitation Statistics

Metric	Value
Total Precipitation	84.2 mm
Maximum Daily Precipitation	17.4 mm
Days with Rain	9 days

According to Table 1, the total recorded precipitation was 84.2 mm, which is considered substantial for such a short period. The maximum daily rainfall was reported as 17.4 mm, indicating intense and concentrated precipitation on certain days. In total, nine rainy days were recorded during this period, leading to soil saturation and reduced infiltration capacity.

A more detailed analysis of the data shows that the most severe rainfall occurred on the 1st and 3rd of Farvardin (March 21 and 23). These heavy rainfalls led to soil saturation, the overflow of water channels, and an increase in river levels. Given this pattern, the occurrence of flooding in the days that followed was highly predictable. With the use of early warning systems or real-time meteorological data analysis, it would have been possible to reduce damages through timely and preventive actions.

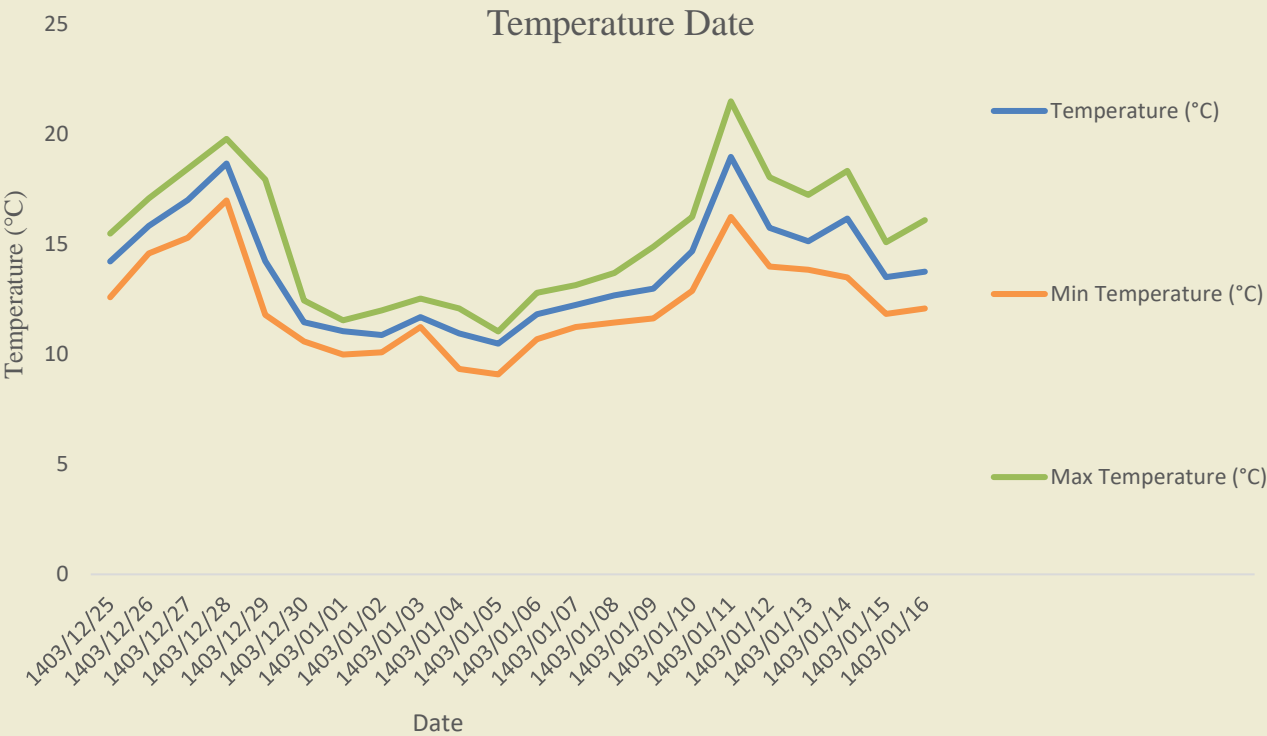
Chart 2: Temperature Statistics

Metric	Value
Average Temperature	13.8°C
Minimum Temperature	9.1°C
Maximum Temperature	21.5°C

It is also noteworthy that on Bahman 28 (February 18), the temperature reached 20°C, indicating a gradual warming trend prior to the flood event. This increase in temperature likely led to early snowmelt in the highlands, which increased surface runoff and intensified flood conditions.

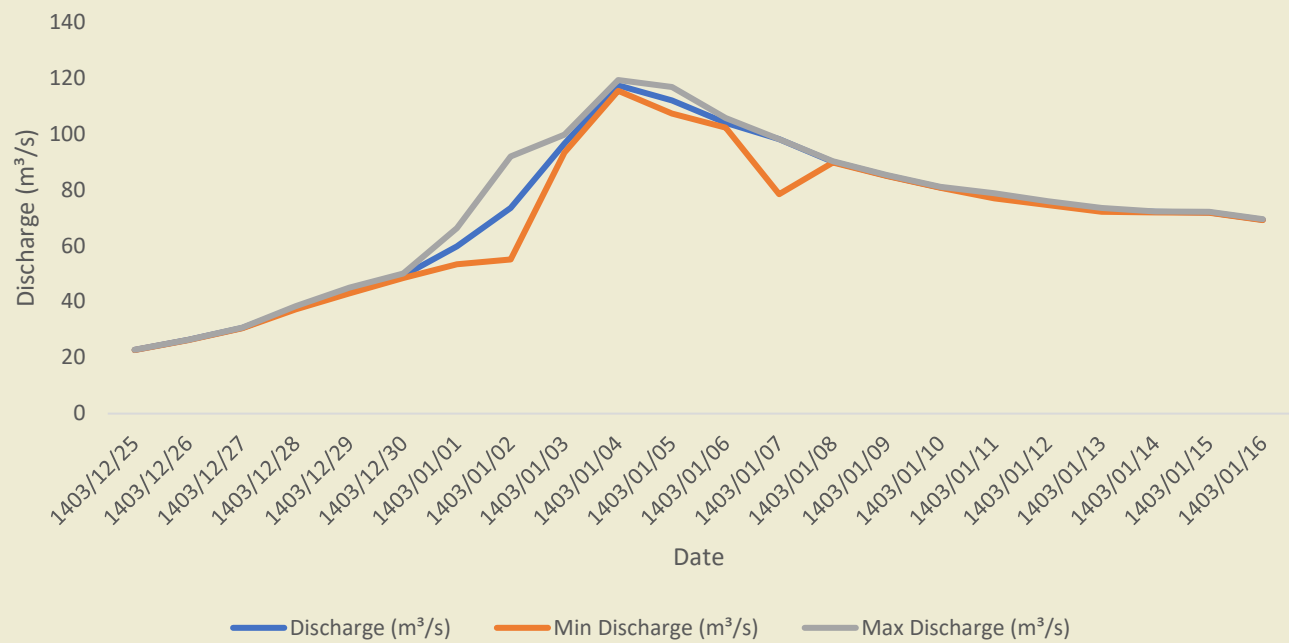
Chart 3: Discharge Statistics

Metric	Value
Average Discharge	71.2 m³/s
Minimum Discharge	22.8 m³/s
Maximum Discharge	119.2 m³/s

Furthermore, river discharge data from Farvardin 4 (March 24) shows that the discharge peaked at 119.2 cubic meters per second, the highest value recorded during the entire period. These figures reflect the flow status of the nearest river adjacent to the area, which was directly affected by heavy rainfall and snowmelt. This sudden increase in river discharge played a major role in the overflow and resulting flooding in the region.
